**Flood Control Project Maintenance
Levee Inspections**
LMA District Cover Sheet
Spring 2009 Levee Inspection Results

Reclamation District No. 1601

Levee Inspection Report By Mile - Spring 2009

Waterway	Bank	Unit Miles	Inspection Start/End	Inspector
Unit No. 01 Threemile Slough	Left	2.50	04/15/2009 04/15/2009	Richard Willoughby

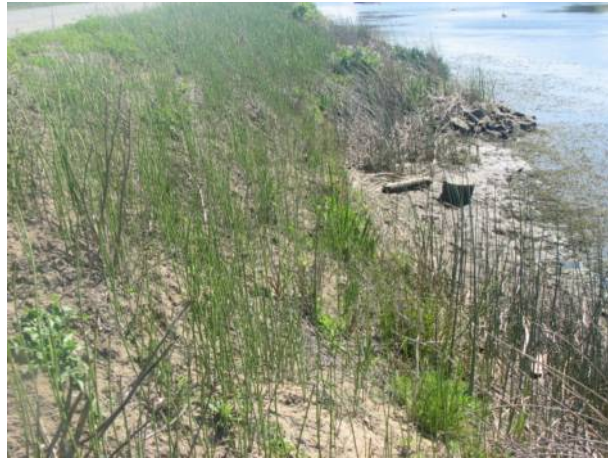
Levee Mile Report Line	3
Start Levee Mile	0.20
End Levee Mile	0.25
Location	Water Side
Category	Earthen Levee
Item	Erosion / Bank Caving

LMR Line	Levee Mile		Category	Item	Location *	Rating **	Action/Comment	GPS Latitude/Longitude		Photo	Issue
	Start	End						Start	End		
1	0.00	2.47	Earthen Levee	Vegetation	WS	M	Control annual grass and weeds on the levee slopes and easements.	38.122262 ° -121.682480 °	38.087740 ° -121.683485 °		2
2	0.00	2.47	Earthen Levee	Vegetation	LS	M	Control annual grass and weeds on the levee slopes and easements.	38.122262 ° -121.682480 °	38.087738 ° -121.683485 °		1
3	0.20	0.25	Earthen Levee	Erosion / Bank Caving	WS	M	Note and monitor erosion site.	38.119517 ° -121.682907 °	38.118767 ° -121.682907 °	Y	3

Looking downstream at erosion site

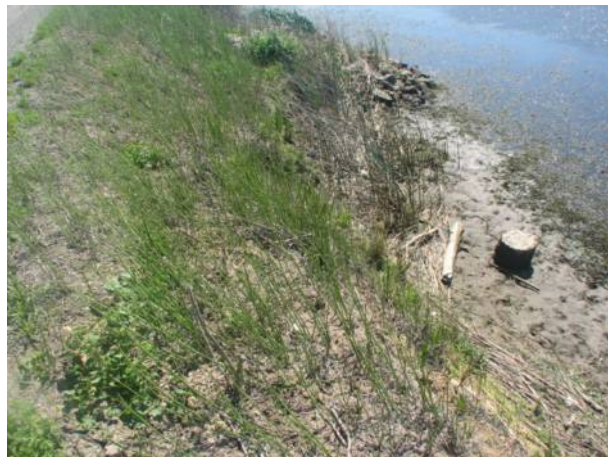
Levee Mile Report Line	3
Start Levee Mile	0.20
End Levee Mile	0.25
Location	Water Side
Category	Earthen Levee
Item	Erosion / Bank Caving

Looking from the top of the levee at erosion site.

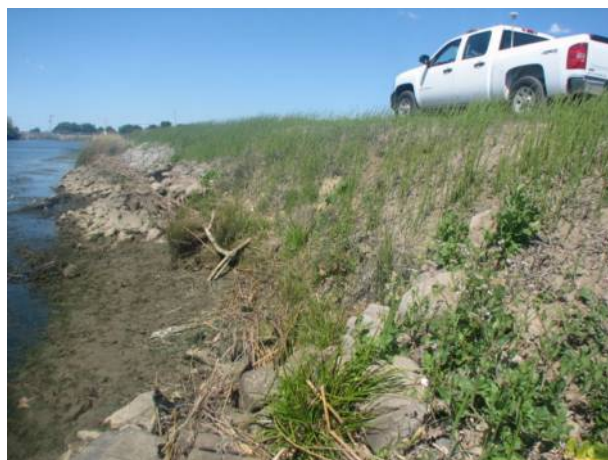
Levee Mile Report Line	3
Start Levee Mile	0.20
End Levee Mile	0.25
Location	Water Side
Category	Earthen Levee
Item	Erosion / Bank Caving

Looking upstream at second erosion site.
